CCM Technical Maintenance Bulletin

Bulletin 12 - November 13, 2012

Hutchens Rocker Replacement

Replacement of Hutchens Rockers due to Bushing Wear

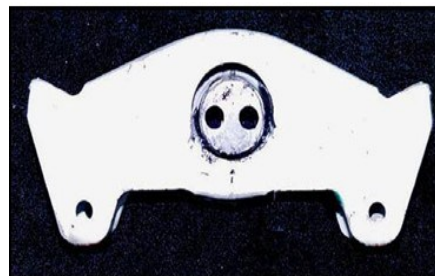
Photo 1: 7700 style 2-bolt rocker with worn bushing.

A 7700 style 2-bolt rocker bushing is shown in photos 1 and 2. As the rocker is exposed to loading, articulation, and the elements, the rubber on the bottom of the bushing will eventually be displaced and/or wear away. This allows the rocker to move up in the hanger toward the trailer frame, but the rocker will still pivot around the steel core of the bushing.

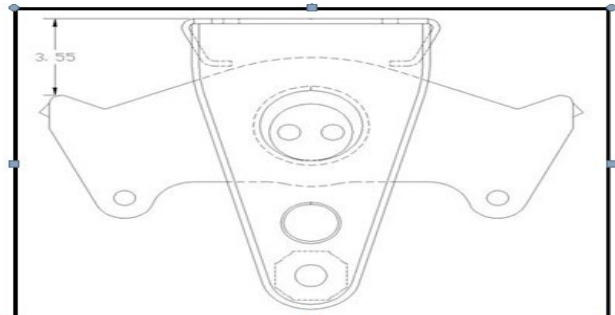
When the rocker moves upward in the hanger toward the positions shown in Figures 2 and 4, metal to metal contact is imminent either at the bushing, or at the top of the rocker. When the rocker is in contact with the top of the hanger as shown in Figure 4, it can no longer articulate and equalize the axle loads. In both cases, the rocker should be replaced before further damage occurs. Prior to this amount of displacement, the rockers are still functional although the articulation may be limited.

Fig. 2: 7700 Rocker with worn bushing.

Replacement should occur before the rocker becomes worn through the bottom, and before the hanger becomes damaged from contact with the rocker. The sketches on the following page will provide guidelines for determining if replacement of the rocker is necessary.
