## Technical Bulletin

No. 29

### Topic: Rim Replacements

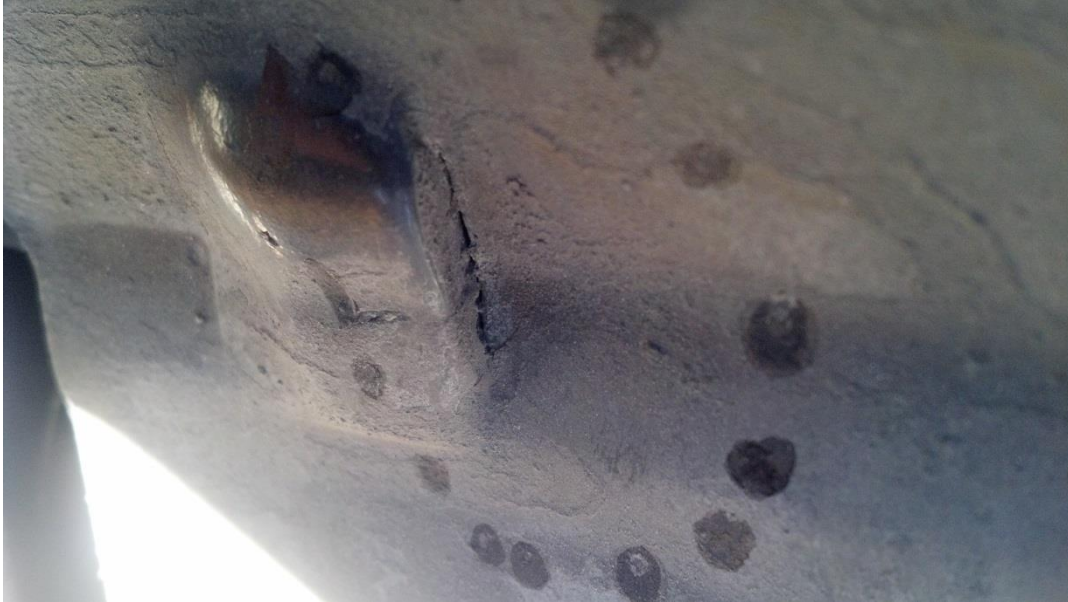
Caution must also be taken when evaluating "cracks" in the rim adjacent to the raised area of the valve stem locator. I have encountered several new rims that had scratches or cracks in the paint adjacent to the raised area of the valve stem locator that has been misinterpreted as a crack in the rim. When a "crack" appears in this area it needs to be thoroughly cleaned and inspected. Only if the metal is cracked should the rim be replaced. As a reminder only the following should be considered as legitimate reasons for rim replacement

Cracked Paint only – Not damage

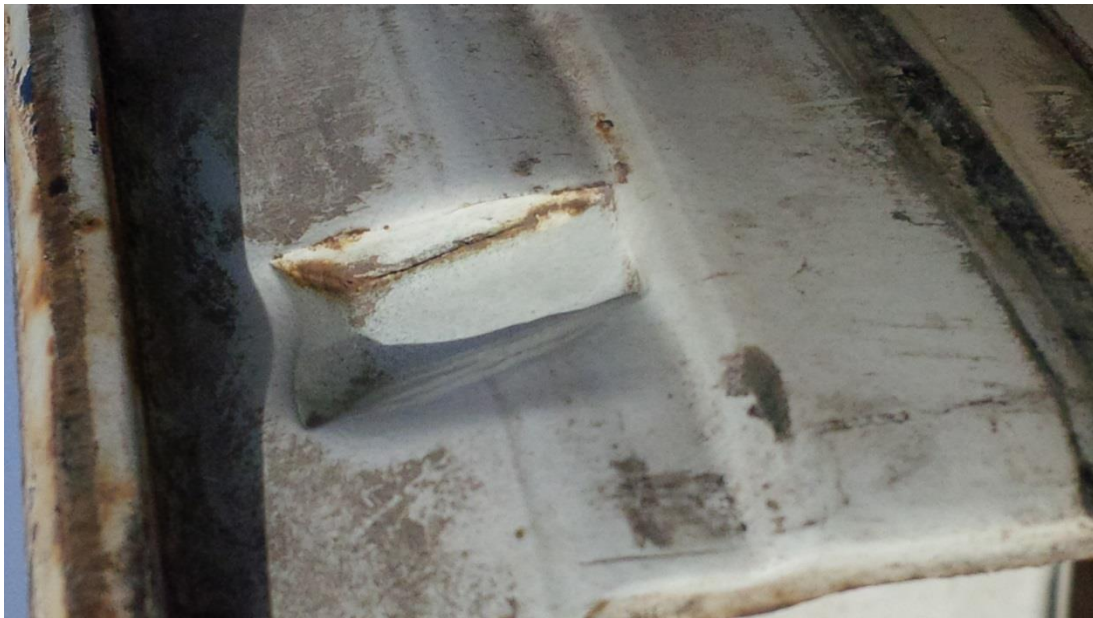
Close up of raised area of the valve stem locator from the bottom (inside) of rim.  
Cracks in the paint only no damage evident

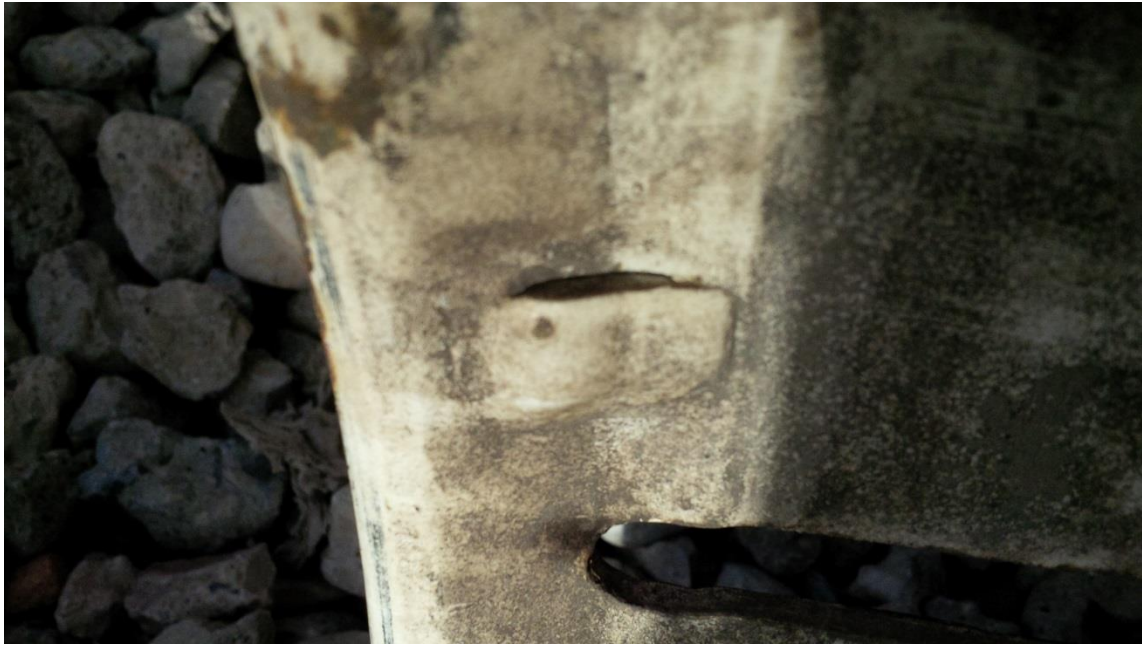
No Damage. Cracks in coating only

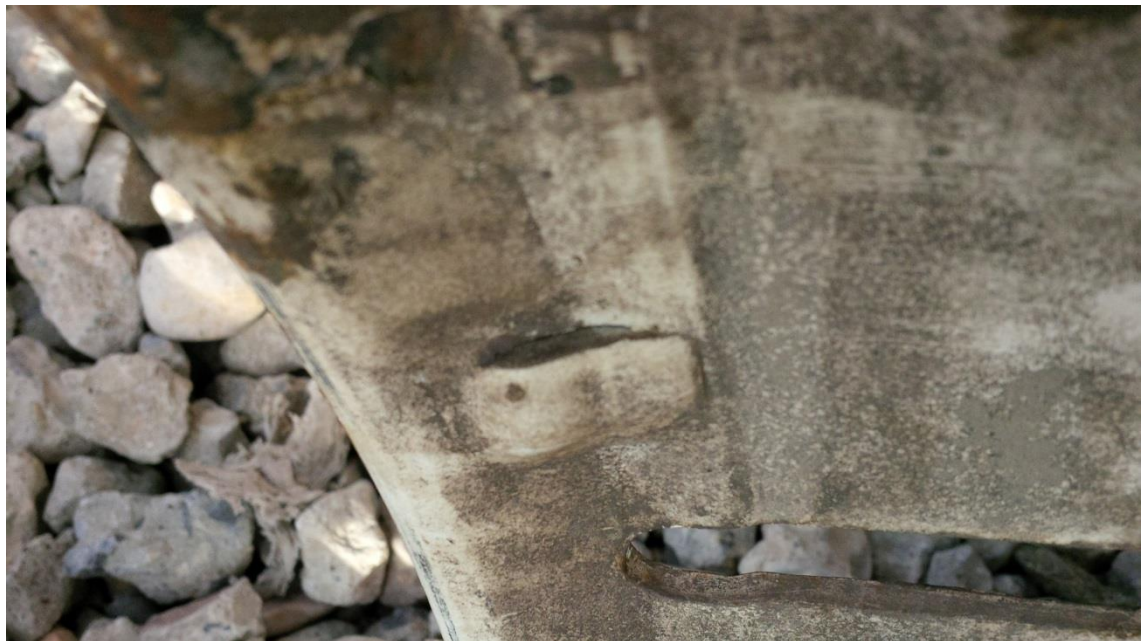
Even though light can be seen between the raised portion of the stop and the rim base, this is not damage
