**Technical Bulletin**

**No. 43**

**Topic:** Hyundai 40/45 Main Rail Failure

# REPAIR METHOD FOR 40'/45' EXT-NO 1

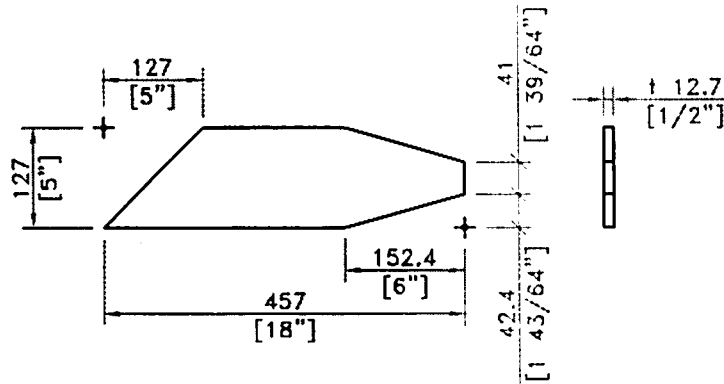
Minor repair is identified by a crack in the bottom horizontal flange only directly adjacent to the expander transition. The crack does not extend into the rail vertical web. Minor repair procedure as follows:

1. Using a 3/16" bit, stop drill the crack in the main beam at its highest point.
2. Carefully grind a bevel in to all cracks to ensure 100% penetration
3. Weld all cracks using carbon steel rods such as E7018 or equivalent
4. Grind all surfaces as required to remove excess buildup
5. Install doubler plate as depicted in attached drawing RFC-025 underneath the bottom flange as depicted in attached repair procedure drawing

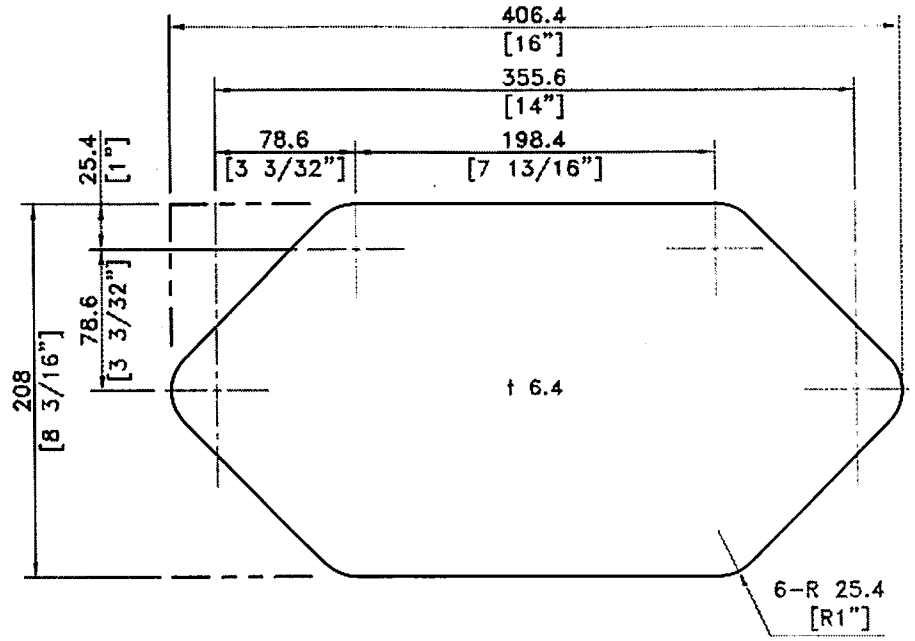
Major repair is identified by a crack in the bottom horizontal flange directly adjacent to the expander transition that extends into the rail vertical web as depicted in the attached drawings. Major repair procedure is as follows:

1. Using a 3/16" bit, stop drill the crack in the main beam at its highest point.
2. Carefully grind a bevel in to all cracks to ensure 100% penetration
3. Weld all cracks using carbon steel rods such as E7018 or equivalent
4. Grind all surfaces as required to remove excess buildup
5. Install doubler plates as indicated on the attached drawings to the outside of the main rail and the underside of the bottom flange
6. Ensure that all repairs are cleaned primed and painted

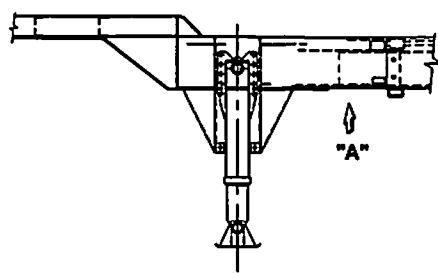
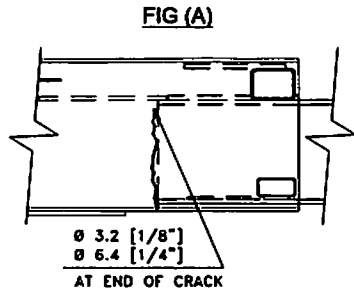
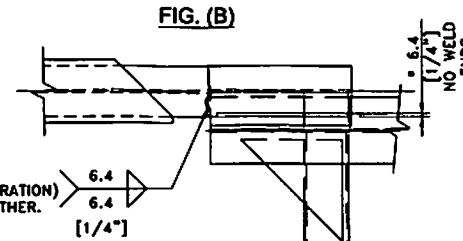
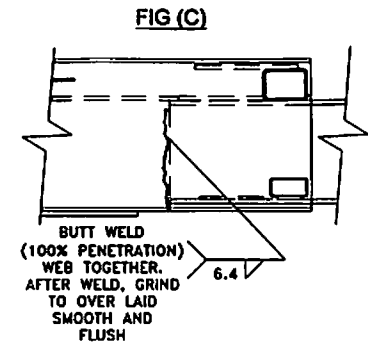
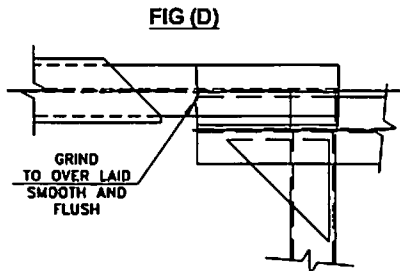
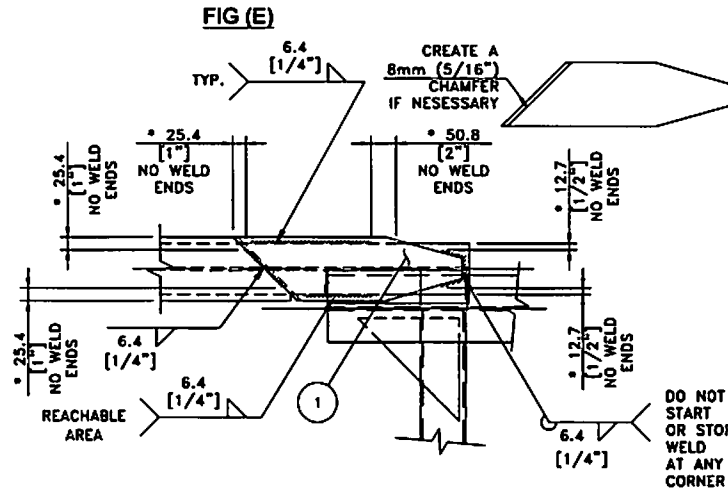
**\*WITH MAIN BEAM WEB CRACK\***

- CLEAN AFFECTED AREAS PRIOR TO ANY WELDING.
- DRILLING 3.2 TO 6.4 mm (1/8" TO 1/4") DIAMETER, STOP HOLE AT END OF CRACK (FIG. A).
- VEE GROOVE ANY CRACKS AND BUTT WELD TOGETHER (FIG. B & C).
- GRIND WELDS THAT WILL HAVE REINFORCEMENTS OVER LAID SMOOTH AND FLUSH (FIG. C & D).
- APPLY REINFORCEMENT AS SHOWN (FIG. E & F).
- EXCEPT INDICATIONS 6.4 NO WELD ANY OPEN ENDS.
- CLEAN WELDS AND AFFECTED AREA AS REQUIRED AND PRIME AND FINISH PAINT AS REQUIRED.
