**Technical Bulletin**

**No. 43**

**Topic:** Hyundai 40/45 Main Rail Failure

# REPAIR METHOD FOR 40'/45' EXT-NO 1

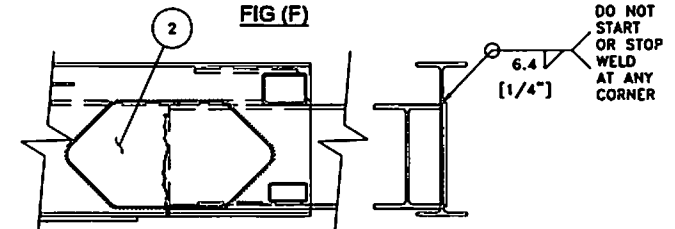
Major repair is identified by a crack in the bottom horizontal flange directly adjacent to the expander transition that extends into the rail vertical web as depicted in the attached drawings. Major repair procedure is as follows:

**\*WITH MAIN BEAM WEB CRACK\***

1. Using a 3/16" bit, stop drill the crack in the main beam at its highest point.
2. Carefully grind a bevel in to all cracks to ensure 100% penetration
3. Weld all cracks using carbon steel rods such as E7018 or equivalent
4. Grind all surfaces as required to remove excess buildup
5. Install doubler plates as indicated on the attached drawings to the outside of the main rail and the underside of the bottom flange
6. Ensure that all repairs are cleaned primed and painted

- CLEAN AFFECTED AREAS PRIOR TO ANY WELDING.
- DRILLING 3.2 TO 6.4 mm (1/8" TO 1/4") DIAMETER, STOP HOLE AT END OF CRACK (FIG. A).
- VEE GROOVE ANY CRACKS AND BUTT WELD TOGETHER (FIG. B & C).
- GRIND WELDS THAT WILL HAVE REINFORCEMENTS OVER LAID SMOOTH AND FLUSH (FIG. C & D).
- APPLY REINFORCEMENT AS SHOWN (FIG. E & F).
- EXCEPT INDICATIONS 6.4 NO WELD ANY OPEN ENDS.
- CLEAN WELDS AND AFFECTED AREA AS REQUIRED AND PRIME AND FINISH PAINT AS REQUIRED.
