CCM Technical Maintenance Bulletin

Bulletin 11 - October 10, 2011

Channel Cracking / Tire Defects

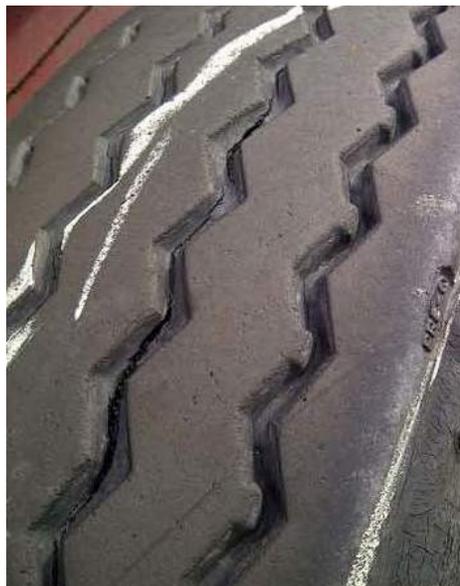
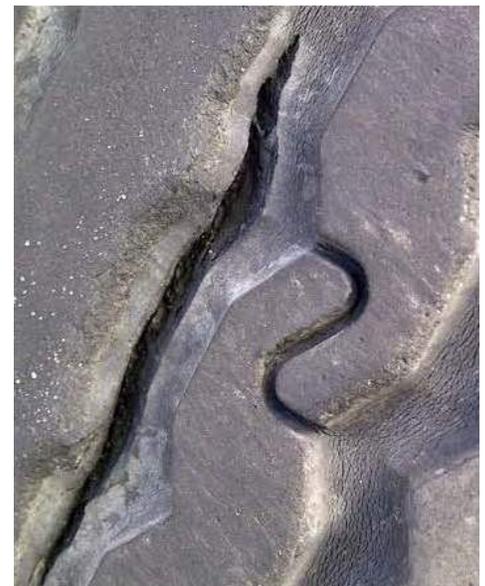
The key consideration in determining when to remove a tire from service is evidence of exposed cord. If the cord is plainly visible such as those in the following pictures the tire must be removed.

NOTE: Neither the length of the split, nor the number of splits is of consideration. *The **sole consideration on whether the tire is to be removed from service is the depth of the splits.*** Splits in the channels of the tire should be carefully probed to determine if there is exposed cord. If the cord is exposed, either visually or it can be felt with a probe, the tire should be removed for service. If the cord cannot be felt or seen visually - the tire is to be left on the chassis.
